737-7/8/8200/9/10  
AIRCRAFT MAINTENANCE MANUAL

CHAPTER 56  
WINDOWS

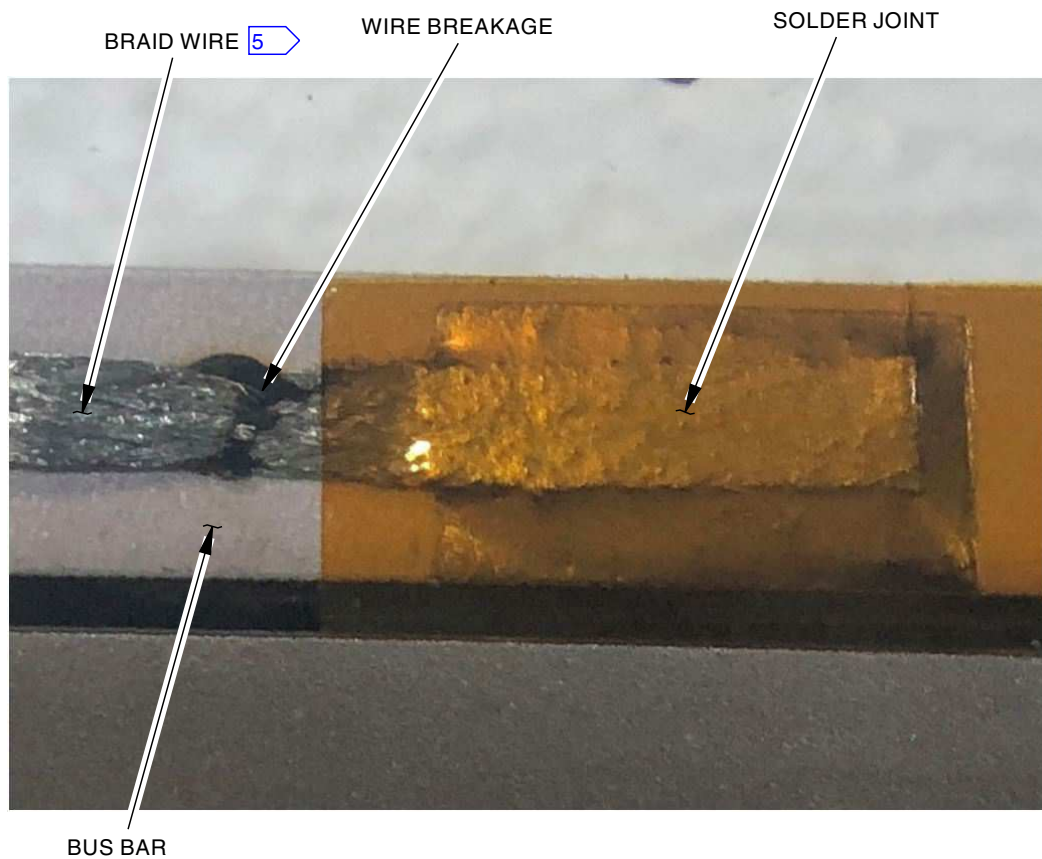
Windshield Z-Bar Disbond and Arcing at Bus Bar and Braid Wire Solder Joint  
Figure 609/56-11-00-990-814 (Sheet 6 of 6)

INSPECT POWER BRAID WIRE ADJACENT TO SOLDER JOINT FOR SIGNS OF BROKEN WIRES AND EVIDENCE OF ELECTRICAL ARCING.
