CHAPTER 56 WINDOWS

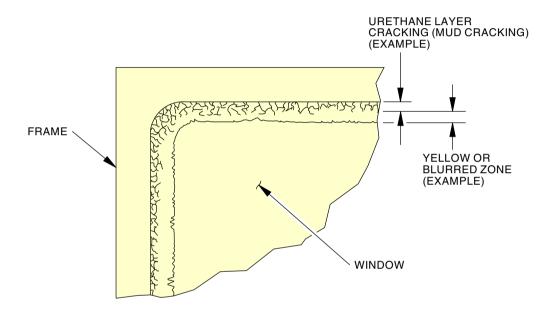
URETHANE INTERLAYER CRACKS

Urethane Interlayer Cracks Figure 601/56-11-00-990-818

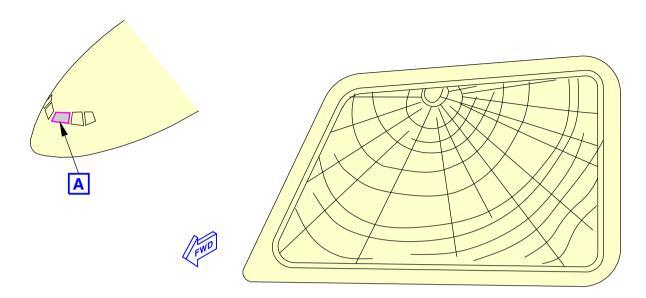
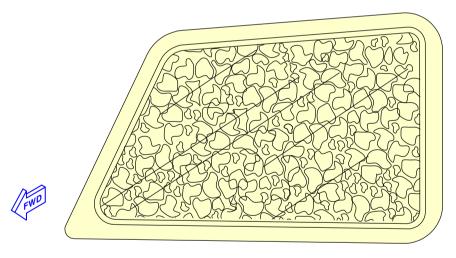
GLASS PANE CRACKS (NON-STRUCTURAL)

GLASS PANE CRACKS (STRUCTURAL)

- (b) Structural glass panes These structural inner glass panes will break into many small irregularly shaped pieces, typically no larger than 0.5 in. (12.7 mm) maximum dimension. Visual quality is significantly decreased. (Example: Figure 603 or Figure 604).

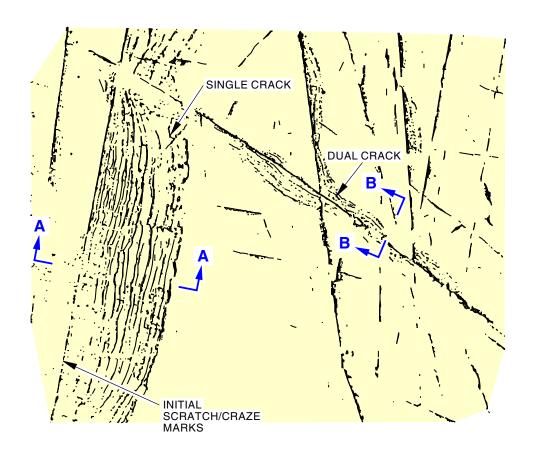
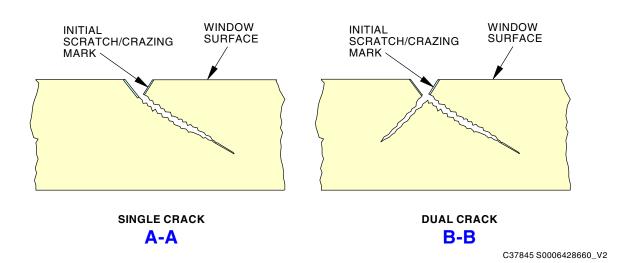
WINDOW SURFACE DAMAGE

Outer Window Pane Surface Damage Figure 604/56-11-00-990-801 (Sheet 1 of 2)

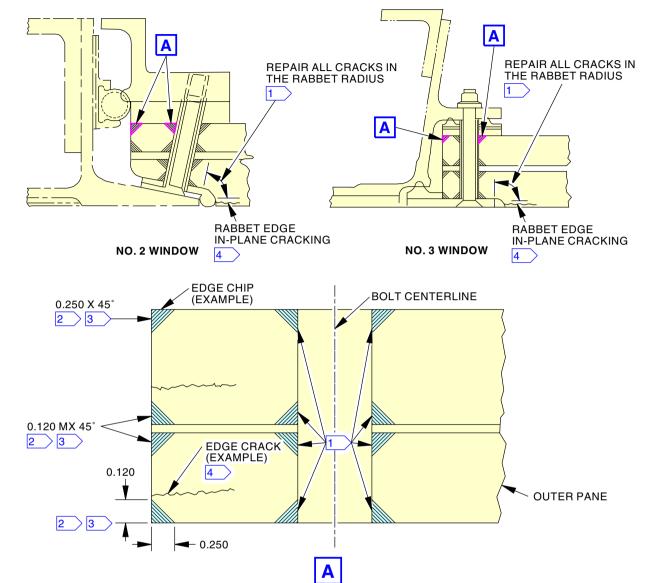
ALL DIMENSIONS ARE IN INCHES.

Outer Window Pane Surface Damage Figure 604/56-11-00-990-801 (Sheet 2 of 2)

- (7) Examine the No. 2 window (acrylic windows only) for edge chips. Figure 604 (Sheet 2)
 - (a) Replace the window if the depth of a chip is greater than the limits shown in the figure.
 - (b) Replace the window if there is more than one chip in a cross section area less than one inch from the centerline of the bolt.

- (8) Examine the No. 2 window (acrylic windows only) for in plane cracking (delamination).
 - (a) Repair in plane cracks that are parallel to the window edge.
 - (b) Repair in plane cracks that are in the rabbet radius (Figure 604 (Sheet 2)) as specified in the component maintenance manual.
 - NOTE: The in plane cracking between the extended acrylic panes and the vinyl interlayer is not a structural problem.

- (6) Examine the No. 3 window (acrylic windows only) for edge chips. (Figure 604 (Sheet 2))
 - (a) Replace the window if the depth of a chip is greater than the limits shown in the figure.
 - (b) Replace the window if there is more than one chip in a cross section area less than one inch from the centerline of the bolt.

- (7) Examine the No. 3 window (acrylic windows only) for in plane cracking (delamination).
 - (a) Repair in plane cracks that are parallel to the window edge.
 - (b) Repair in plane cracks that are in the rabbet radius (Figure 604 (Sheet 2)) as specified in the component maintenance manual.
 - <u>NOTE</u>: The in plane cracking between the extended acrylic panes and the vinyl interlayer is not a structural problem.

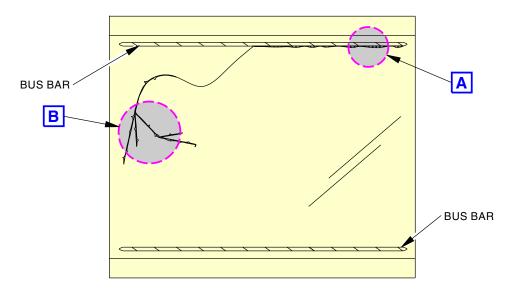
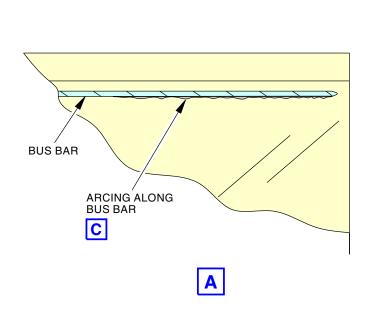
WINDOW HEAT ARCING

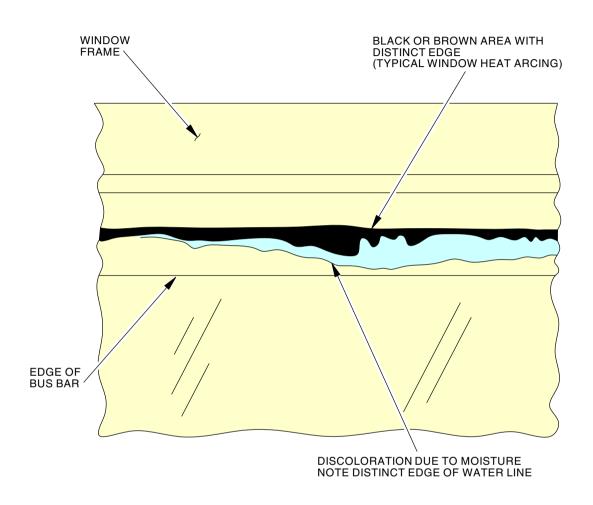
ARCING ALONG BUS BAR

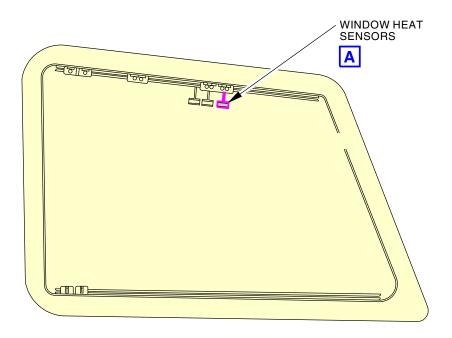
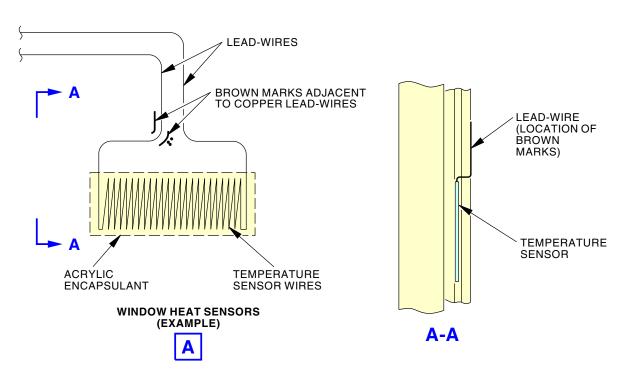
Window Heat Sensor Contamination Figure 606/56-11-00-990-810

(a) Fine lines/streaks near the temperature sensors or the sensors wires are the result of contamination from the manufacturing process, and is not a cause for the removal of the windshield (Figure 606).

- NOTE: The temperature sensors and sensor wires are not powered to heat the window and do not experience arcing. Small dark spots less than 0.1 in. (2.5 mm) or fine lines/streaks near the temperature sensors or the sensors wires are the result of contamination from the manufacturing process, and is not a cause for the removal of the windshield. (Figure 606)

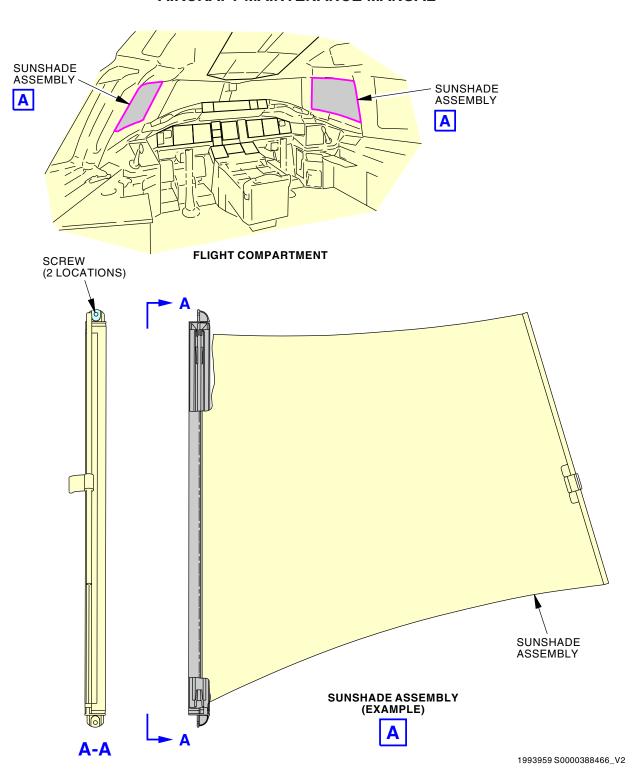
Sunshade Removal and Installation Figure 608/56-11-00-990-817

- (1) Remove the No. 2 window inner shroud linings: (IPC 25-15-01-011)
 - (a) Remove the sunshade assembly: (IPC 25-13-52-08). Figure 608 (Sheet 1)
 - 1) Remove the screws that hold the sunshade assembly to the structure.
 - 2) Remove the sunshade assembly away from the airplane.
 - (b) Remove the No. 2 window sunshade tracks (IPC 25-13-01-002).
 - (c) Remove the chart holders (IPC 25-13-01-401).
 - (d) Remove the No. 2 window inner lining panel assemblies.

- (d) Install the window shade assembly (IPC 25–13–52–08). Figure 608 (Sheet 1)
 - 1) Install the sunshade in its position.
 - 2) Install the two screws that hold the sunshade to the structure.

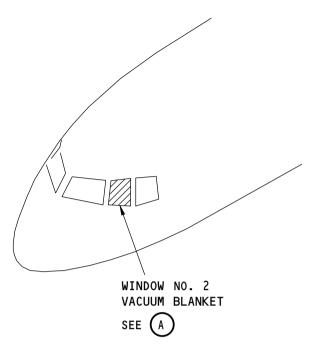
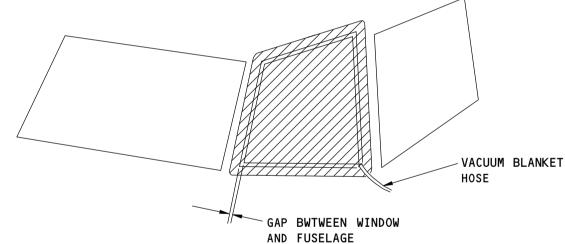
WINDOW NO. 2 VACUUM BLANKET

NOTE: THE VACUUM BLANKET COVERS THE ENTIRE WINDOW AND THE GAP BETWEEN THE WINDOW AND THE FUSELAGE.

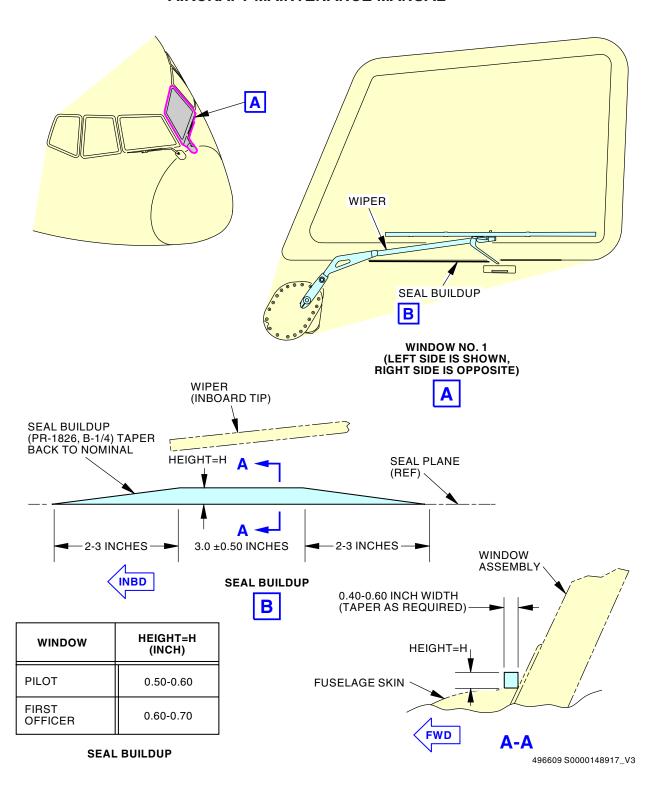
Seal Buildup Wiper Window No. 1 Figure 801/56-11-00-990-807

(1) Use this procedure to repair fluttering and unparked window windshield wipers (Figure 801).

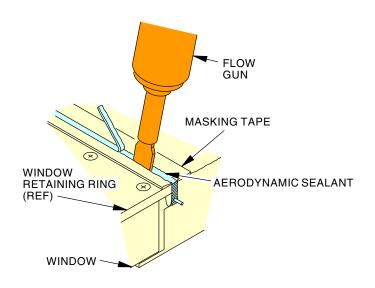
AERODYNAMIC SEALANT REPAIR

Aerodynamic Sealant and Moisture Sealant Repair Figure 802/56-11-00-990-813 (Sheet 1 of 4)

- (2) Remove unwanted sealant above the z-bar with an approved sealant removal tool (Prepare For Sealing, TASK 51-31-01-160-801)(Figure 802).
 - NOTE: The z-bar will come into view as an embedded flat metal strip along the periphery of the window laminate.
 - NOTE: If you are not sure of the sealant's quality, remove approximately 0.12 in. (3.05 mm) of sealant from the edge.

(a) Let the PR-1425 sealant, A00103 or alternative PR 1829 sealant, A01056 dry before you touch the seal. Figure 802

(b) Let the PR-1784 sealant, A50164 dry before you touch the seal. Figure 802

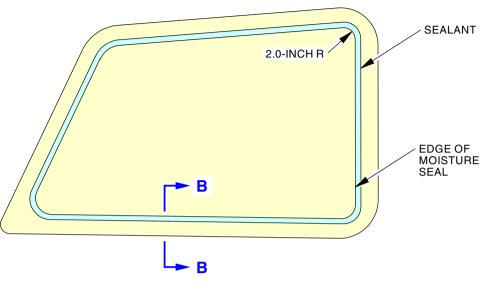
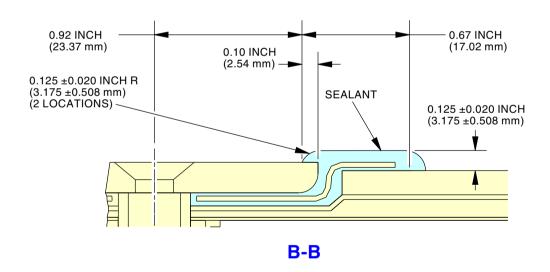
NO. 1 WINDOW

Aerodynamic Sealant and Moisture Sealant Repair Figure 802/56-11-00-990-813 (Sheet 2 of 4)

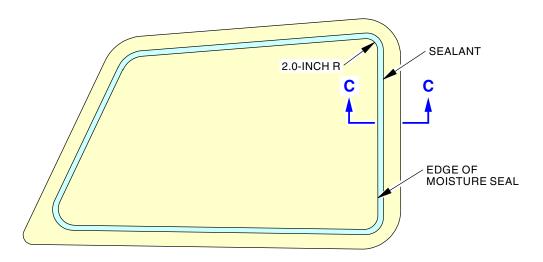
NO. 1 WINDOW

Aerodynamic Sealant and Moisture Sealant Repair Figure 802/56-11-00-990-813 (Sheet 3 of 4)

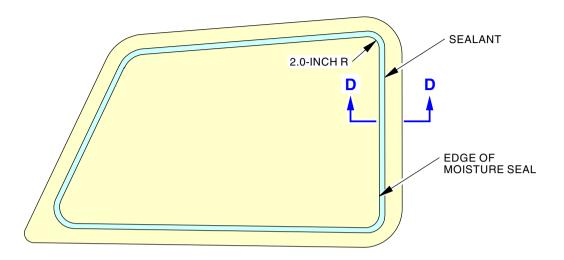
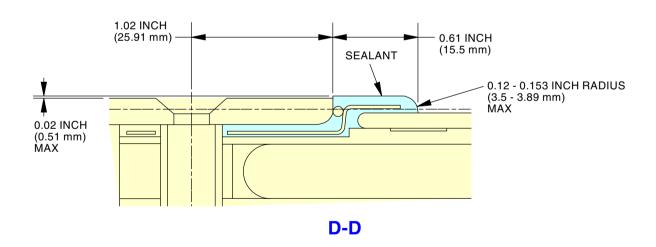
NO. 1 WINDOW

Aerodynamic Sealant and Moisture Sealant Repair Figure 802/56-11-00-990-813 (Sheet 4 of 4)

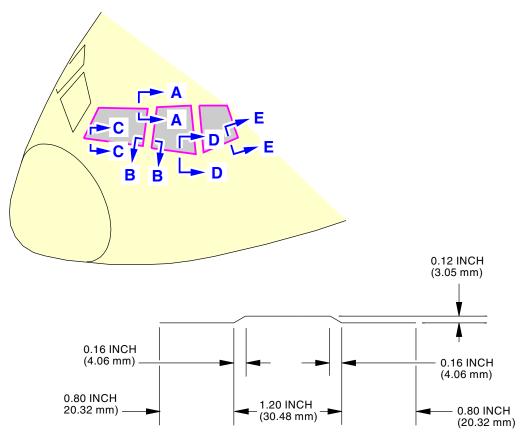
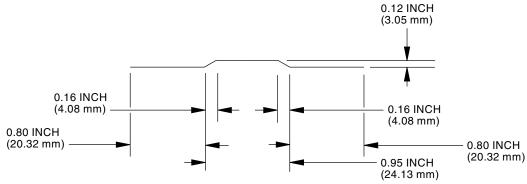
TOOL FOR UPPER MOISTURE SEAL - MAXIMUM WIDTH (OPTIONAL)

TOOL FOR OUTBOARD MOISTURE SEAL - MAXIMUM WIDTH (OPTIONAL)

- (b) Shaping tools may be fabricated for the moisture seals on the No. 1 window (Figure 802Figure 805).
 - 1) See Figure 805 for moisture seal configuration on the No. 2 and No. 3 windows.

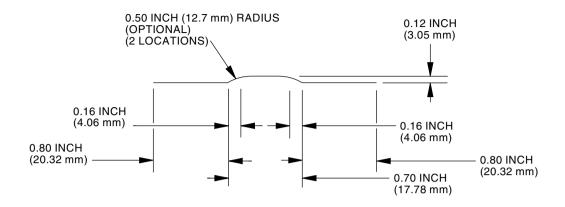
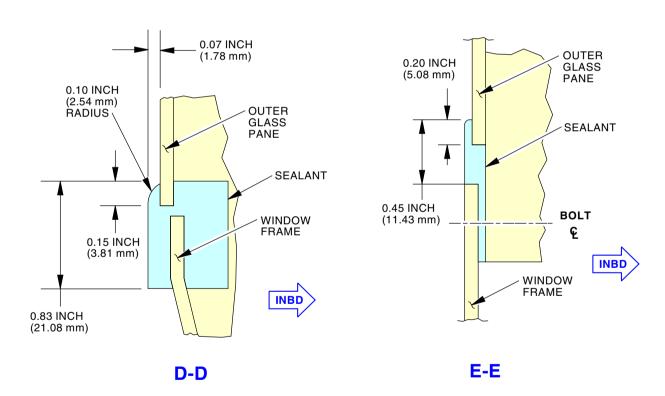
MOISTURE SEAL SHAPING TOOL - INBOARD LOWER SEAL

TOOL FOR NO. 1 WINDOW LOWER AND INBOARD MOISTURE SEAL. OPTIONAL FOR OUTBOARD AND UPPER MOISTURE SEAL

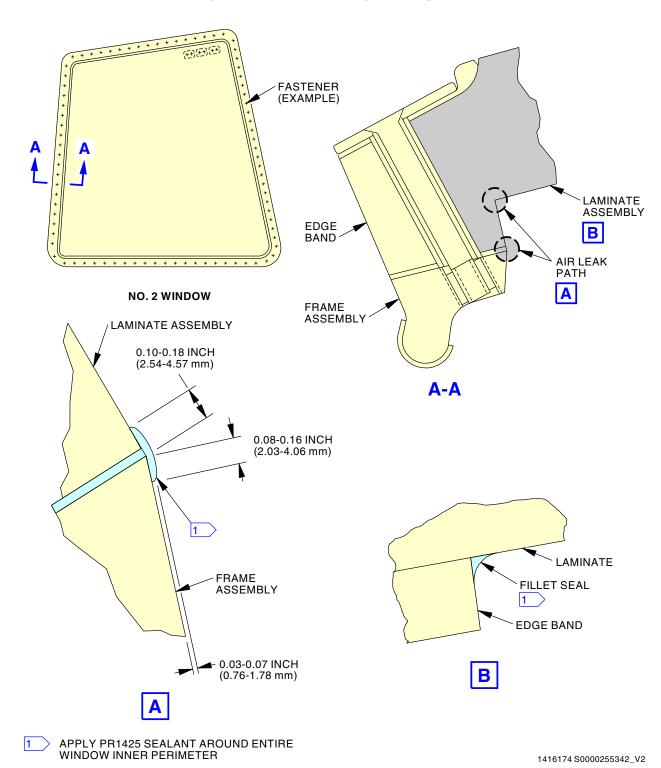
No.2 Window Assembly Repair - Inner Seal Figure 806/56-11-00-990-811

- (4) Look for spaces between the laminate edge band and the laminate assembly (acrylic windows only), and between the laminate band edge and the aluminum frame assembly (Figure 806).
 - (a) If spaces are found, apply sealant to the areas with spaces.

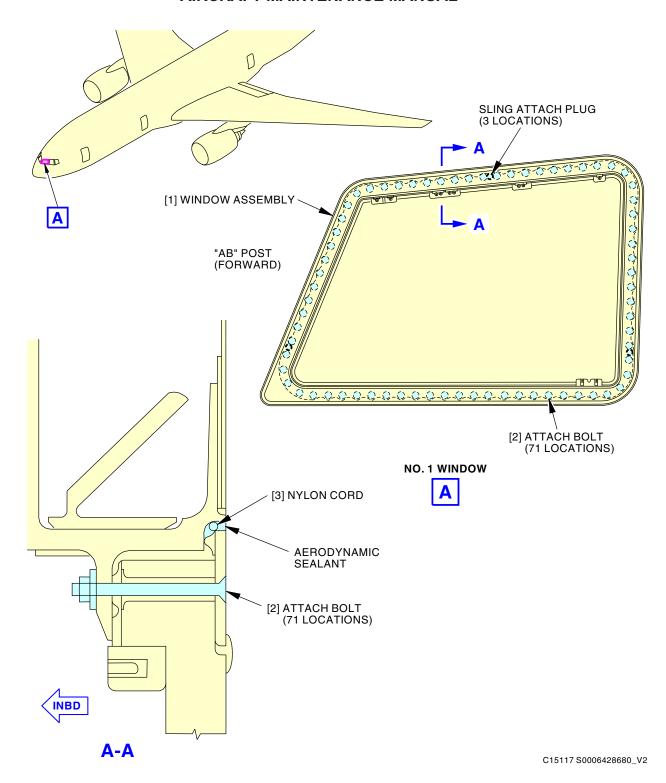
No. 1 Window Installation Figure 401/56-11-01-990-801

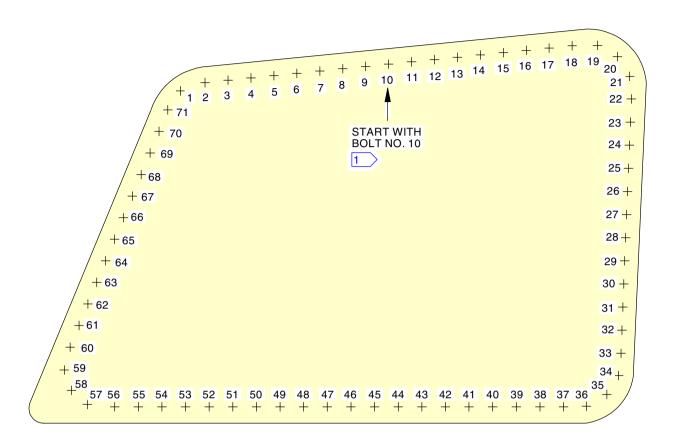
ATTACH BOLT LOCATIONS - WINDOW NO. 1 (LEFT NO. 1 WINDOW SHOWN, RIGHT NO. 1 WINDOW OPPOSITE)

1 TIGHTEN THE BOLTS IN THE ORDER SHOWN IN THE TABLE ON FIGURE 403.

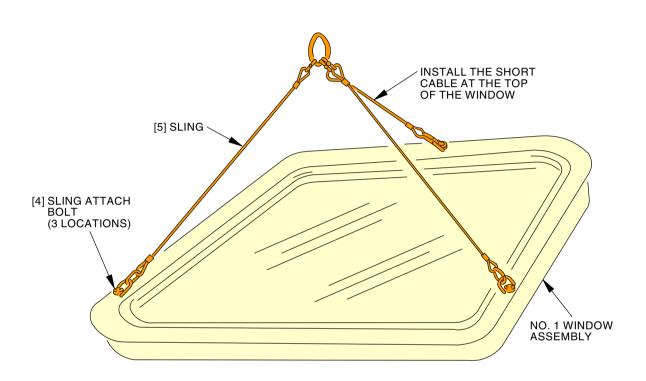
WINDOW HANDLING SLING - A56001-2

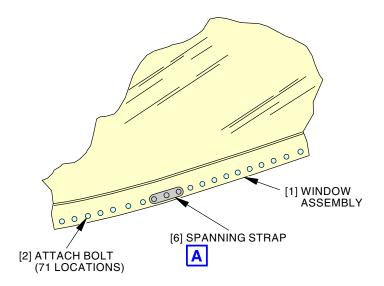
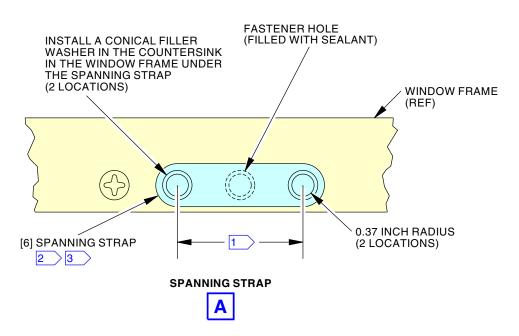
- 1 THIS DIMENSION IS NOT THE SAME AT ALL LOCATIONS
- USE 0.040 INCH THICK 2024-T3/T4 ALUMINUM ALLOY, 0.75 INCH WIDE. DRILL AND COUNTERSINK FOR TWO 100° COUNTERSUNK HEAD BACB30NN4K39 BOLTS. OPTIONAL: DIMPLE THE SPANNING STRAP FOR THE 100° BOLT AND OMIT THE CONICAL FILLER WASHER.
- REMOVE SHARP EDGES TO PREVENT DAMAGE TO THE WINDSHIELD WIPERS

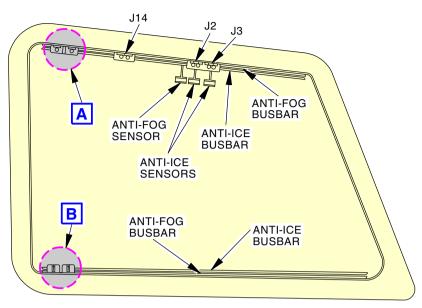
LEFT WINDOW (RIGHT WINDOW IS OPPOSITE)

TERMINAL	RESISTANCE (OHM)	
	MIN	MAX
BETWEEN J1 AND J5	9.12	11.15
J2	1	1
J3	1	1
BETWEEN J13 AND J15	20.20 2	24.70 2
J14	1	1

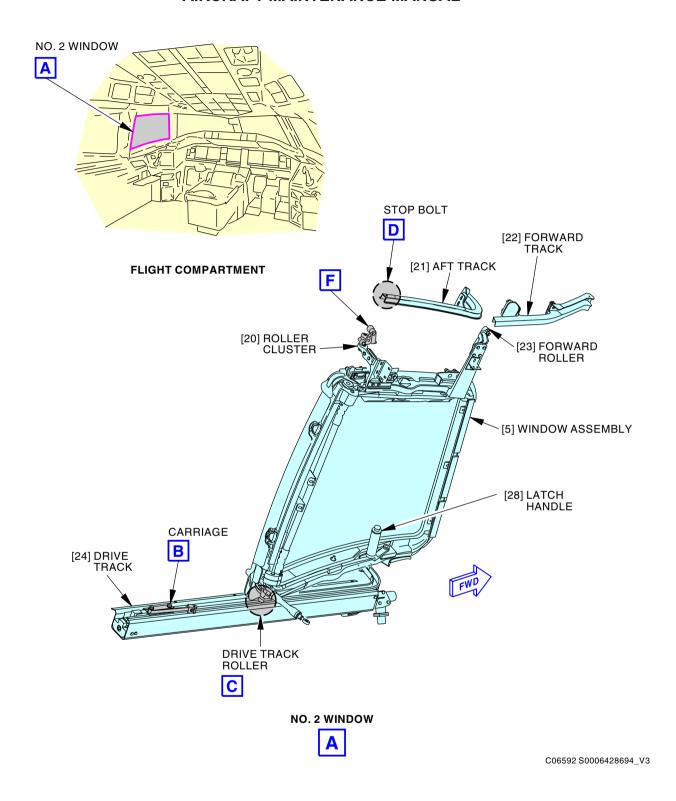
No. 2 Openable Window Installation Figure 401/56-11-02-990-801 (Sheet 1 of 3)

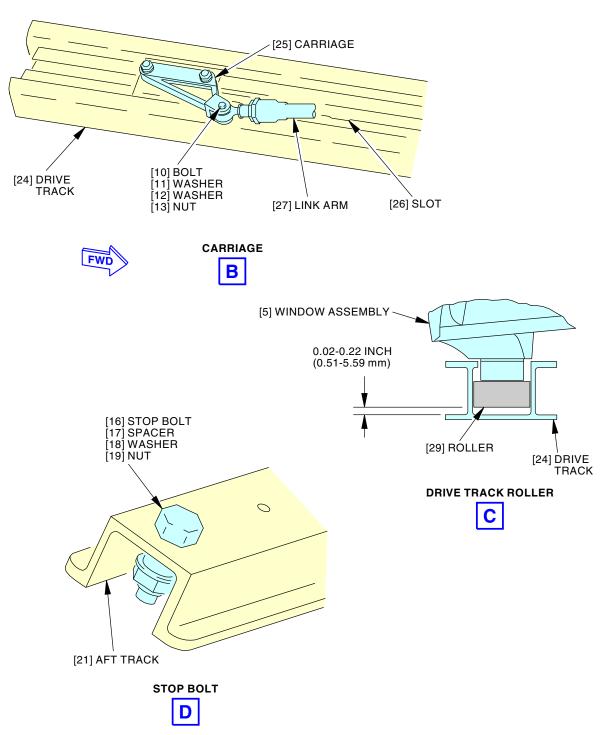
No. 2 Openable Window Installation Figure 401/56-11-02-990-801 (Sheet 2 of 3)

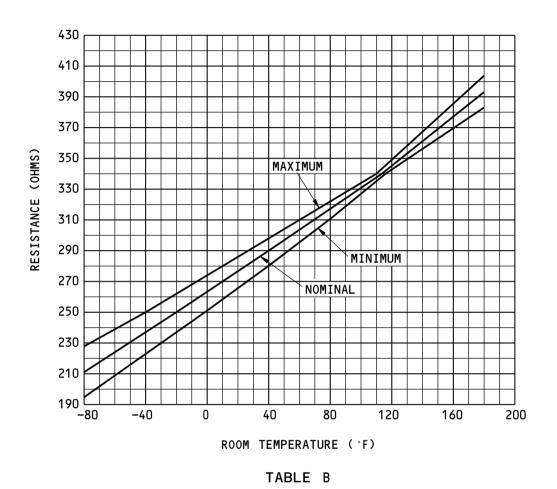
No. 2 Window Resistance Values Figure 402/56-11-02-990-827 (Sheet 2 of 2)

TERMINAL LOCATION	RESISTANCE (OHM)	
200/111011	MIN	MAX
5-6	1	1
3-4	1	1
1-2	16.60	20.28

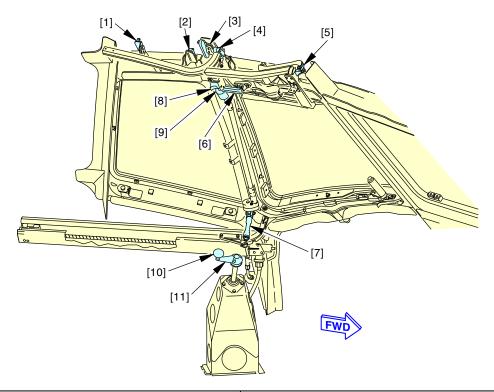
[X]	COMPONENT	ADJUSTMENT	FIGURE
[1]	AFT SUPPORT BRACKET	VERTICAL ADJUSTMENT (AFT SIDE OF THE WINDOW)	503
[2]	MIDDLE SUPPORT BRACKET		
[3]	FORWARD SUPPORT BRACKET		
[4]	AFT ROLLER CLUSTER		
[5]	FORWARD ROLLER CLUSTER	VERTICAL ADJUSTMENT (FORWARD SIDE OF THE WINDOW)	504
[6]	GUIDE ROLLER	FORWARD/AFT ADJUSTMENT (TOP HALF OF THE WINDOW)	505
[7]	LINK ARM	INBOARD/OUTBOARD ADJUSTMENT (BOTTOM AFT CORNER OF THE WINDOW)	506
[8]	CAM BLOCK		
[9]	CRANK ROLLER	INBOARD/OUTBOARD ADJUSTMENT (TOP AFT CORNER OF THE WINDOW)	507
[10]	DRIVE HANDLE KNOB	HANDLE	508
[11]	DRIVE HANDLE

(Figure 501, Figure 502, Figure 503, Figure 504, Figure 505, Figure 506, Figure 507, Figure 508, Figure 509, Figure 510)

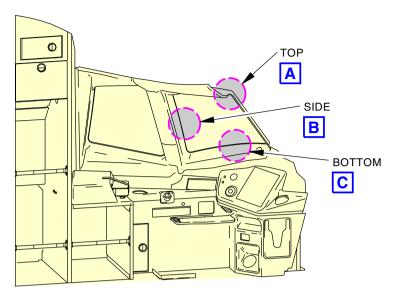
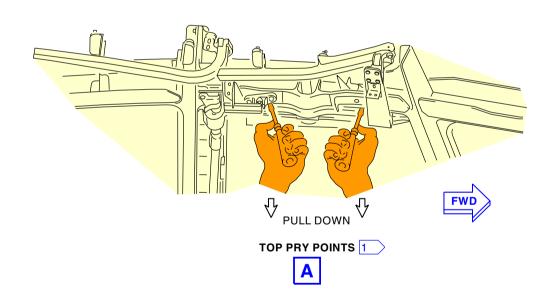
PRY TEST (5 PRY POINTS)

DO THE PRY TEST WITH THE WINDOW CLOSED.
DO NOT APPLY MORE THAN 50 POUNDS OF FORCE TO THE PRY TOOL.

OPERATE THE LATCH HANDLE TO DO A CHECK OF THE HANDLE FORCE WHILE YOU APPLY FORCE AT EACH PRY POINT.

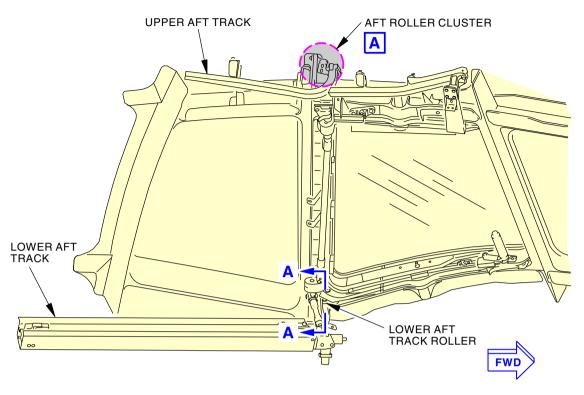
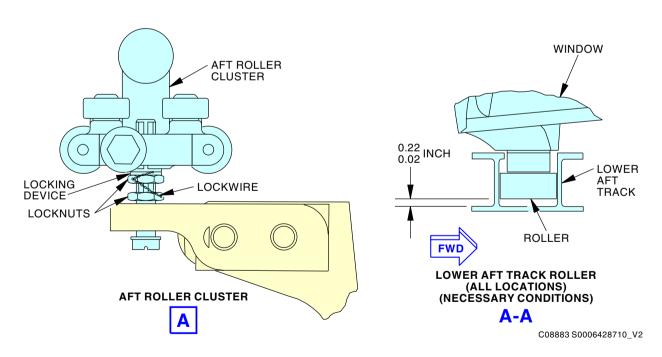
Vertical Adjustment (Aft Side of the Window) Figure 503/56-11-02-990-804 (Sheet 1 of 3)

AFT ROLLER CLUSTER

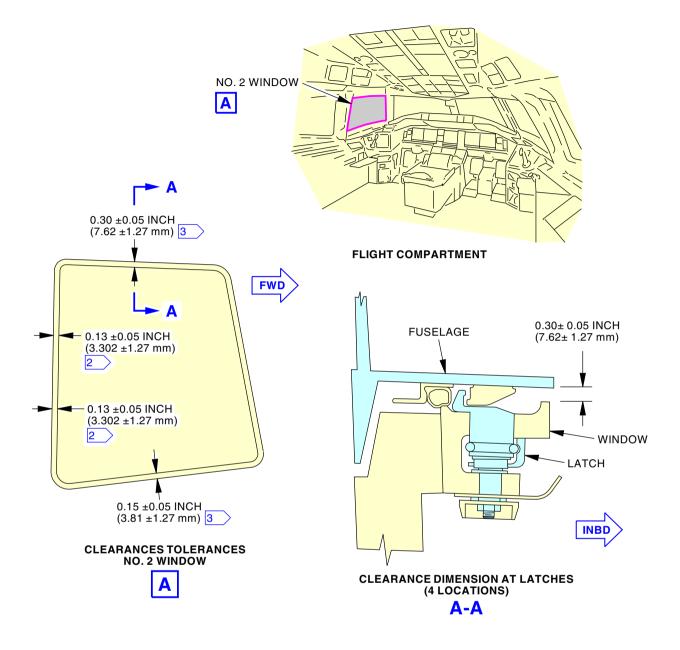
- 1 MEASURE THE CLEARANCES AT THE TOP, AFT AND BOTTOM LATCHES
- THE CLEARANCES AT THE AFT LATCHES MUST ALSO BE WITHIN 0.02 INCH (0.508 mm) OF EACH OTHER.
- THESE ARE NOMINAL DIMENSIONS. IF YOUR AIRPLANE HAS DIFFERENT NOMINAL DIMENSIONS, ADD OR SUBTRACT THE DIFFERENCE EQUALLY BETWEEN THE TOP AND BOTTOM CLEARANCE.

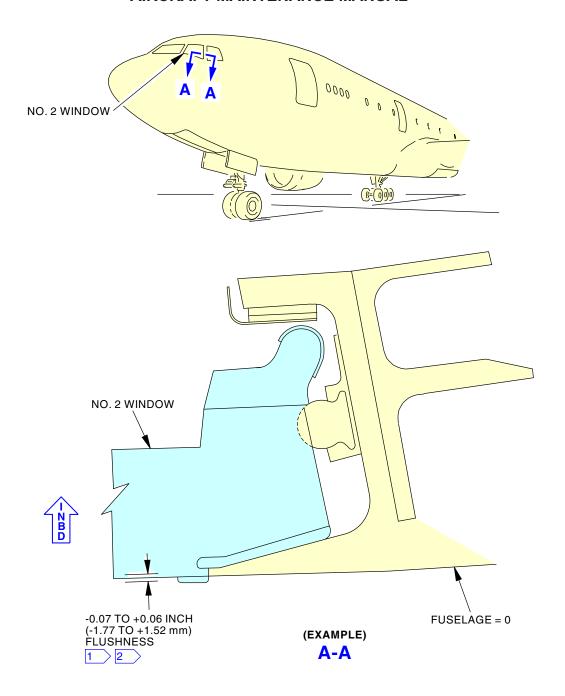
1 A NEGATIVE FLUSHNESS SHOWS THE WINDOW IS INBOARD OF THE FUSELAGE CONTOUR. A POSITIVE FLUSHNESS SHOWS THE WINDOW IS OUTBOARD OF THE FUSELAGE CONTOUR.

2 THE FLUSHNESS TOLERANCE IS FOR ALL SIDES OF THE WINDOW.

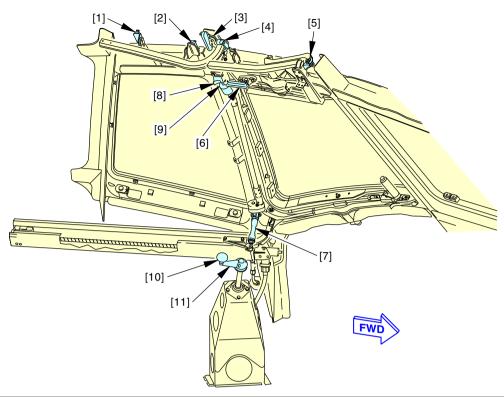
[X]	COMPONENT	CHECK	FIGURE
[1]	AFT SUPPORT BRACKET		
[2]	MIDDLE SUPPORT BRACKET	VERTICAL CHECK	603
[3]	FORWARD SUPPORT BRACKET	(AFT SIDE OF THE WINDOW)	
[4]	AFT ROLLER CLUSTER		
[5]	FORWARD ROLLER CLUSTER	WARD ROLLER CLUSTER (FORWARD SIDE OF THE WINDOW)	
[6]	GUIDE ROLLER	FORWARD/AFT CHECK (TOP HALF OF THE WINDOW)	605
[7]	LINK ARM	INBOARD/OUTBOARD CHECK (BOTTOM AFT CORNER OF THE WINDOW)	606
[8]	CAM BLOCK	INBOARD/OUTBOARD CHECK	
[9]	CRANK ROLLER	(TOP AFT CORNER OF THE WINDOW)	607
[10]	WINDOW CRANK HANDLE KNOB	HANDLE	608
[11]	WINDOW CRANK HANDLE	MANDLE

(3) Compare these actual conditions to the necessary adjustments that will help you get the necessary conditions (Figure 602, Figure 604, Figure 605, Figure 606, Figure 607, Figure 608, Figure 609):

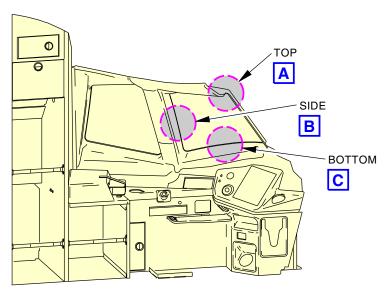
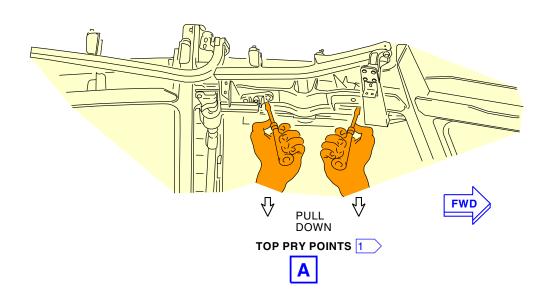
PRY TEST (5 PRY POINTS)

- DO THE PRY TEST WITH THE WINDOW CLOSED.
 DO NOT APPLY MORE THAN 50 POUNDS OF FORCE TO THE PRY TOOL.
- OPERATE THE LATCH HANDLE TO DO A CHECK OF THE HANDLE FORCE WHILE YOU APPLY FORCE AT EACH PRY POINT.

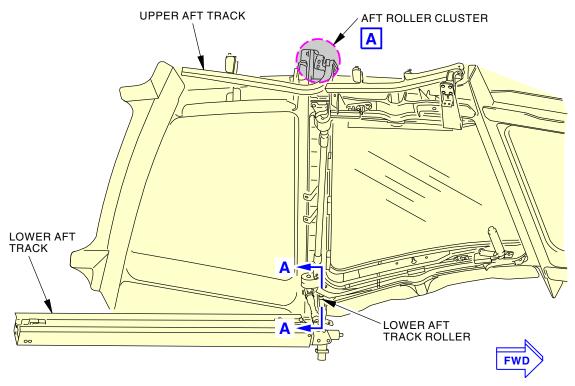
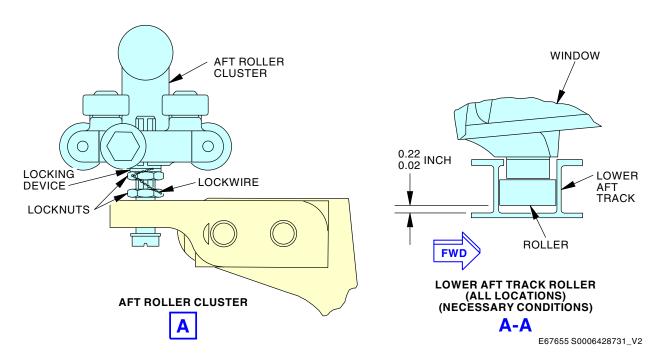
Vertical Check (Aft Side of the Window) Figure 603/56-11-02-990-826 (Sheet 1 of 3)

AFT ROLLER CLUSTER

1) If the window will not move to the almost closed position, adjust the window vertically (Figure 603, Figure 604).

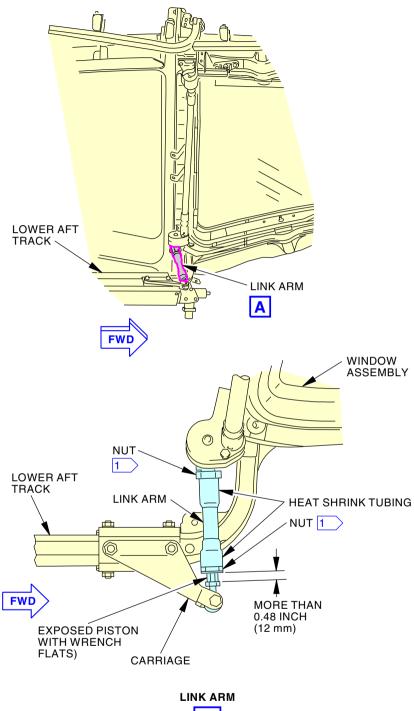
Inboard/Outboard Check (Bottom Aft Corner of the Window) Figure 606/56-11-02-990-819 (Sheet 1 of 2)

1 DO NOT LOOSEN.

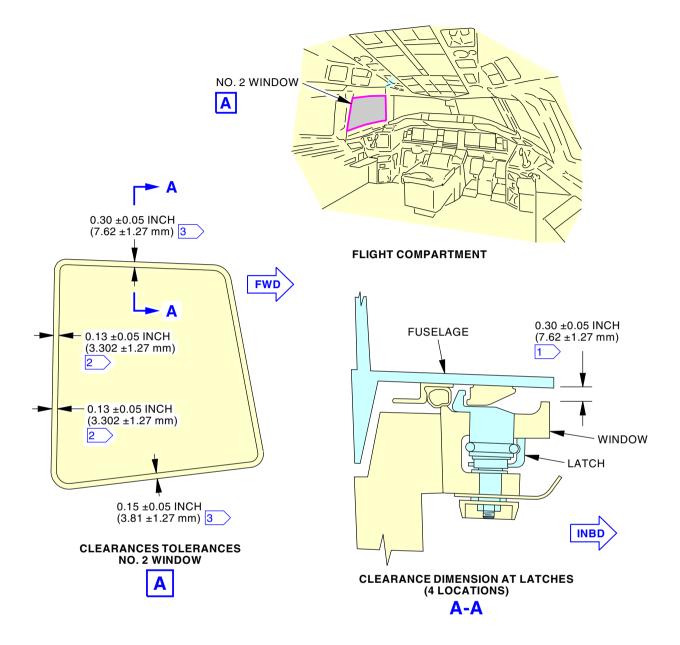
- 1 MEASURE THE CLEARANCES AT THE TOP, AFT AND BOTTOM LATCHES
- THE CLEARANCES AT THE AFT LATCHES MUST ALSO BE WITHIN 0.02 INCH (0.508 mm) OF EACH OTHER.
- THESE ARE NOMINAL DIMENSIONS. IF YOUR AIRPLANE HAS DIFFERENT NOMINAL DIMENSIONS, ADD OR SUBTRACT THE DIFFERENCE EQUALLY BETWEEN THE TOP AND BOTTOM CLEARANCE.

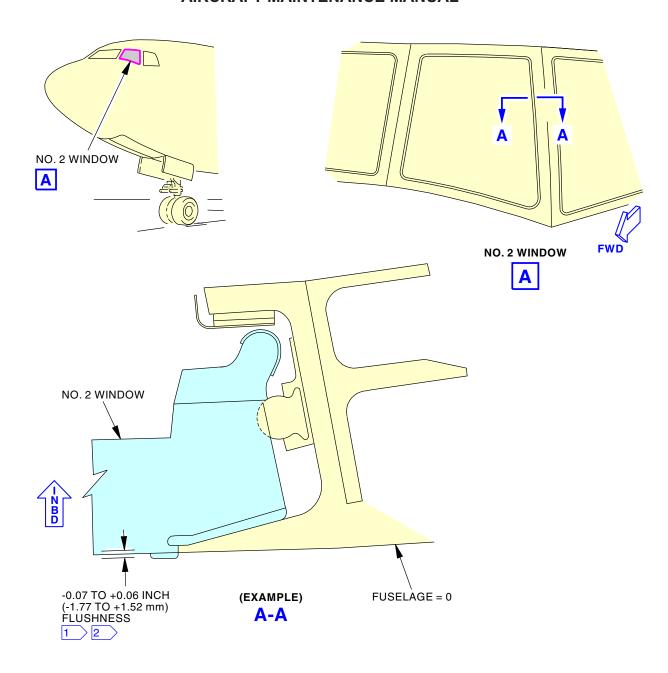
- A NEGATIVE FLUSHNESS SHOWS THE WINDOW IS INBOARD OF THE FUSELAGE CONTOUR.
 A POSITIVE FLUSHNESS SHOWS THE WINDOW IS OUTBOARD OF THE FUSELAGE CONTOUR.
- THE FLUSHNESS TOLERANCE IS FOR ALL SIDES OF THE WINDOW.

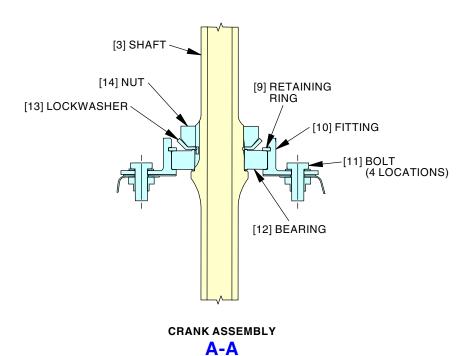
No. 2 Window Operating Mechanism Installation Figure 401/56-11-04-990-801 (Sheet 2 of 3)

FLEXIBLE DRIVESHAFT

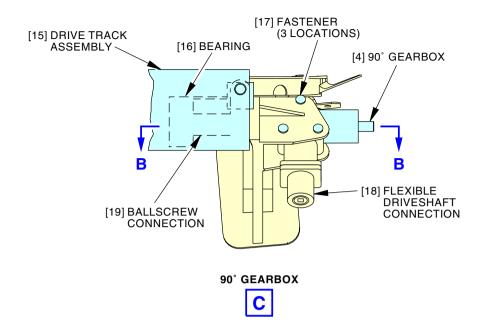
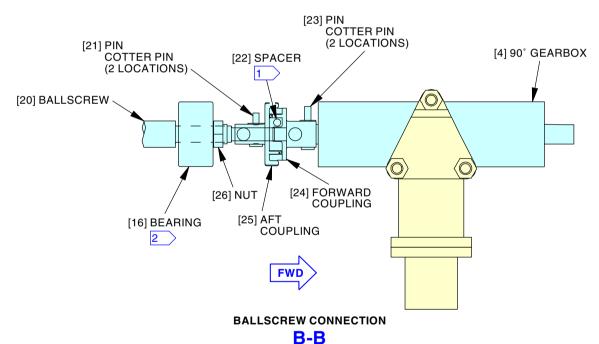
1 OPTIONAL:

YOU CAN BOND THE SPACER TO THE FORWARD COUPLING

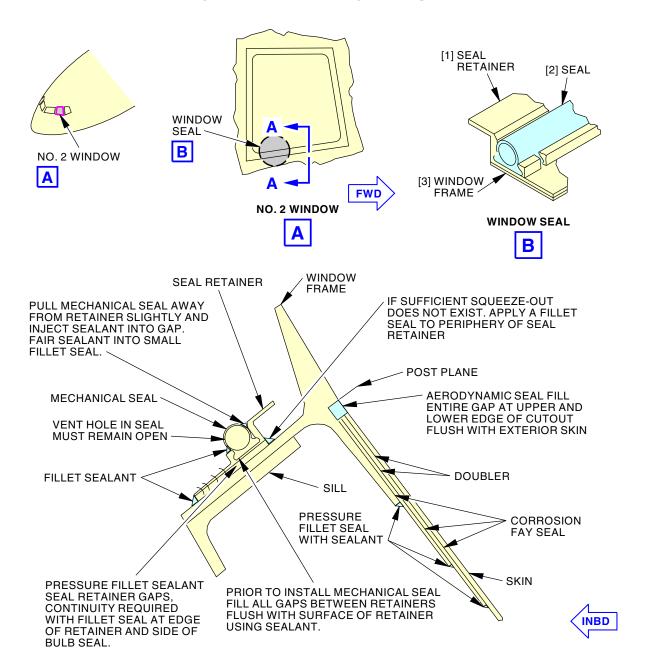
SEALING FOR ENTIRE PERIPHERY OF RETAINER (VIEW IN THE AFT DIRECTION) (EXAMPLE)

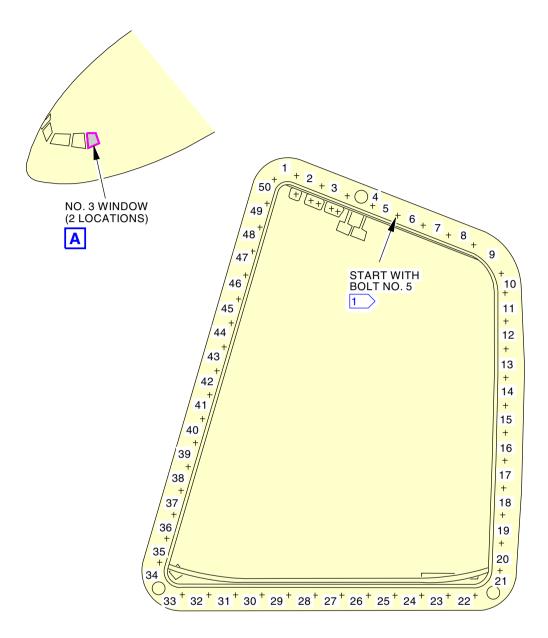
ATTACH BOLT LOCATIONS - NO. 3 WINDOW (LEFT NO. 3 WINDOW IS SHOWN, RIGHT NO. 3 WINDOW IS OPPOSITE)

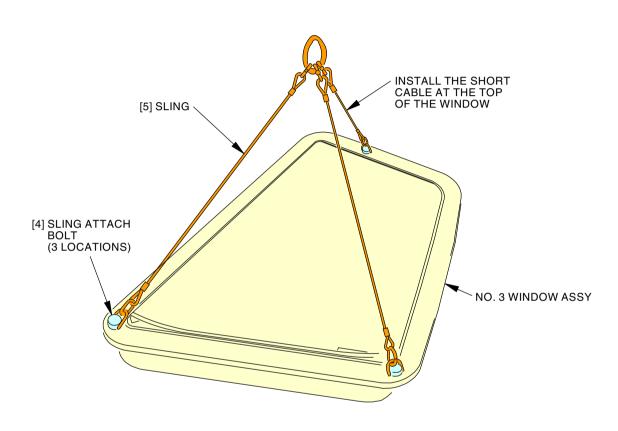
WINDOW HANDLING SLING

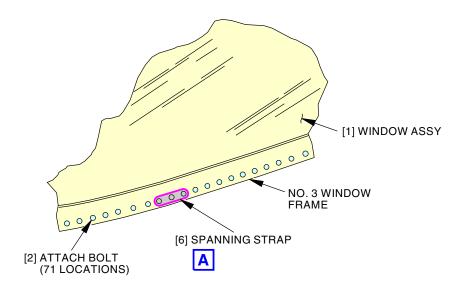
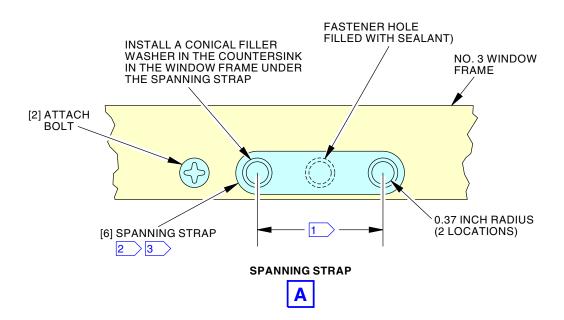
- 1 THIS DIMENSION IS NOT THE SAME AT ALL LOCATIONS
- USE 0.040 INCH THICK 2024-T3/T4 ALUMINUM ALLOY, 0.75 INCH WIDE. DRILL AND COUNTERSINK FOR TWO 100' COUNTERSUNK HEAD BACB30NN4K39 BOLTS. OPTIONAL: DIMPLE THE SPANNING STRAP FOR THE 100' BOLT AND OMIT THE CONICAL FILLER WASHER.
- REMOVE SHARP EDGES FOR AERODYNAMIC SMOOTHNESS

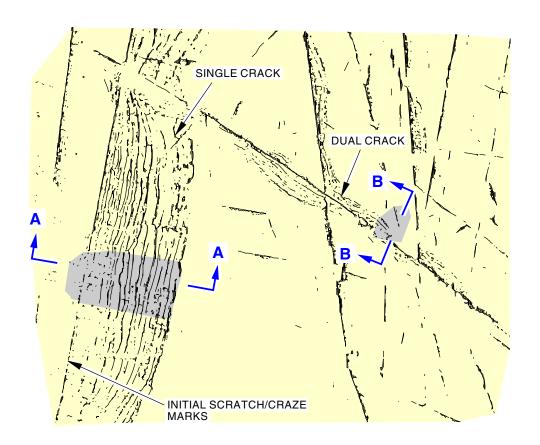
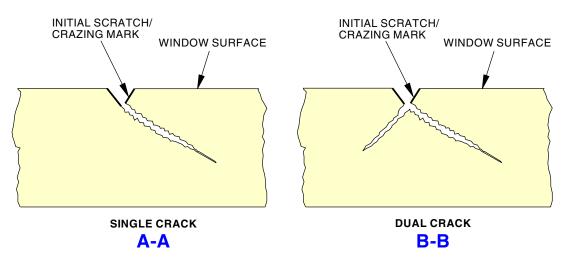
Outer Window Pane Surface Damage Figure 601/56-21-01-990-802

WINDOW SURFACE DAMAGE

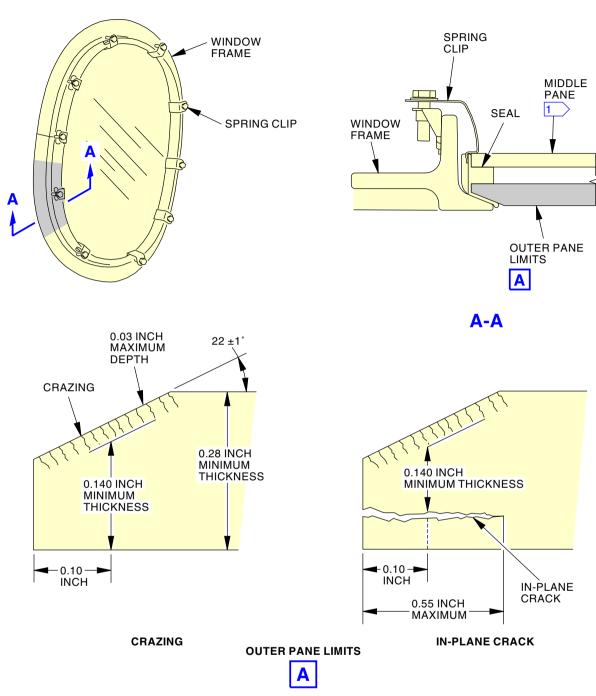
1 REPLACE THE MIDDLE PANE IF THERE ARE CRACKS OR CRAZING.

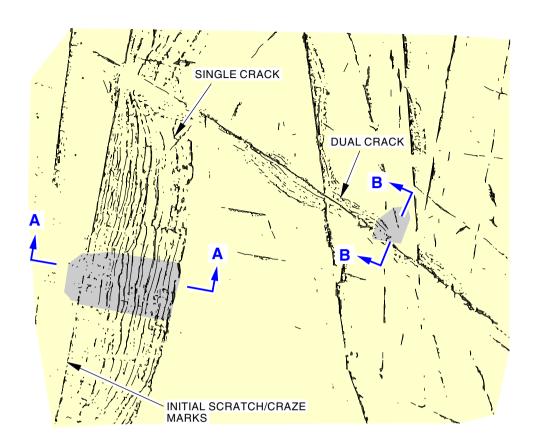
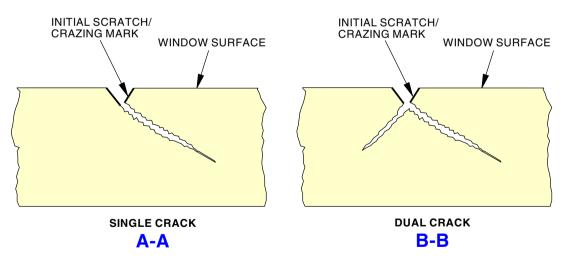
Outer Window Pane Surface Damage Figure 601/56-31-01-990-802

WINDOW SURFACE DAMAGE

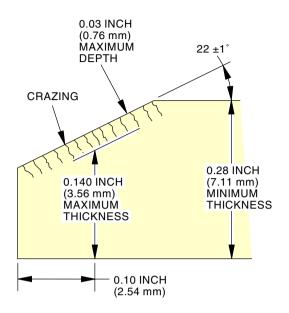
OUTER PANE LIMITS (CRAZING)
